**Oak Brook Park District  
1450 Forest Gate Road  
Oak Brook, IL 60523**

**REQUEST FOR LETTERS OF INTEREST AND STATEMENTS OF QUALIFICATIONS FOR  
PROFESSIONAL SERVICES**

# Bridge Condition & Alternative Analysis Report

# GINGER CREEK CONTROL FACILITIES

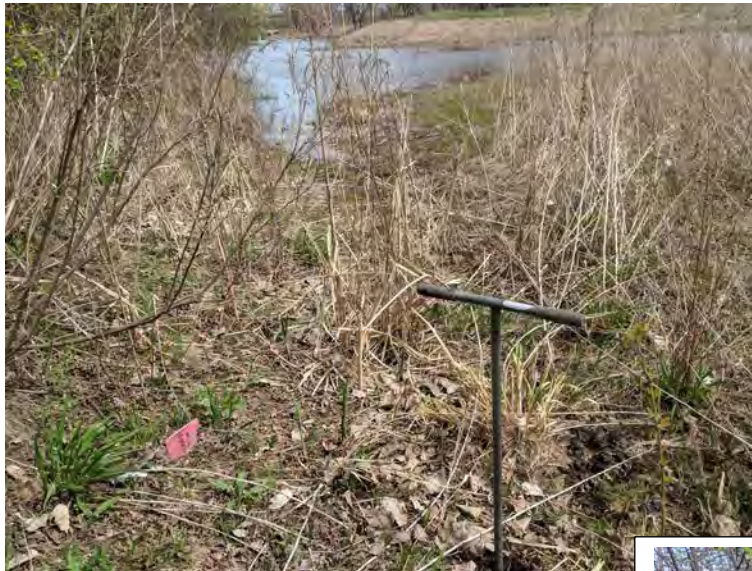
**Photo 1:** View from Data Point 1A in Wetland 1 looking east.

Site Photographs (Exhibits 7A & 7B) were taken at the time of the April 22, 2019 site visit to show the areas investigated and the conditions of the site. Exhibit 7A shows Wetland 1 and the adjacent upland. Exhibit 7B shows Wetland 2, the adjacent upland, and an area of wetland vegetation growing within Waters 1.

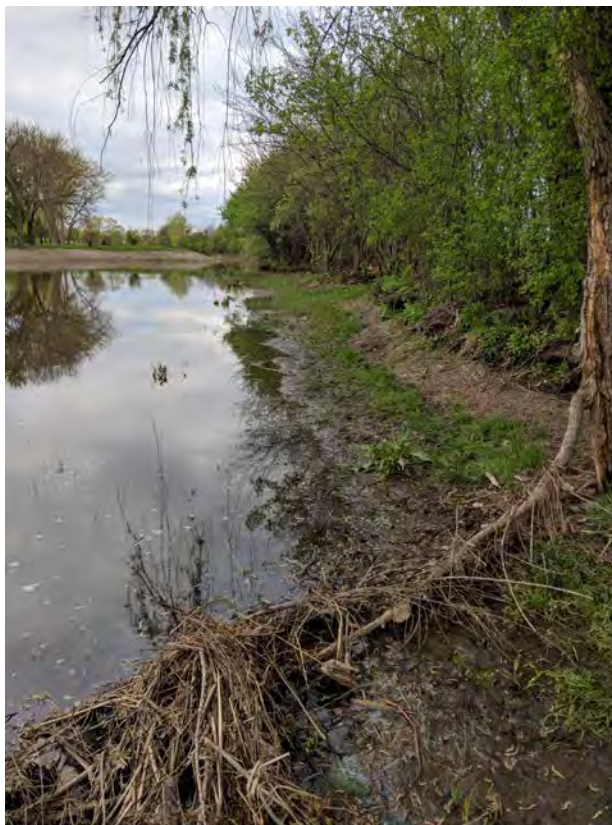
**Photo 2:** View from Data Point 1B in the upland adjacent to Wetland 1 looking east.

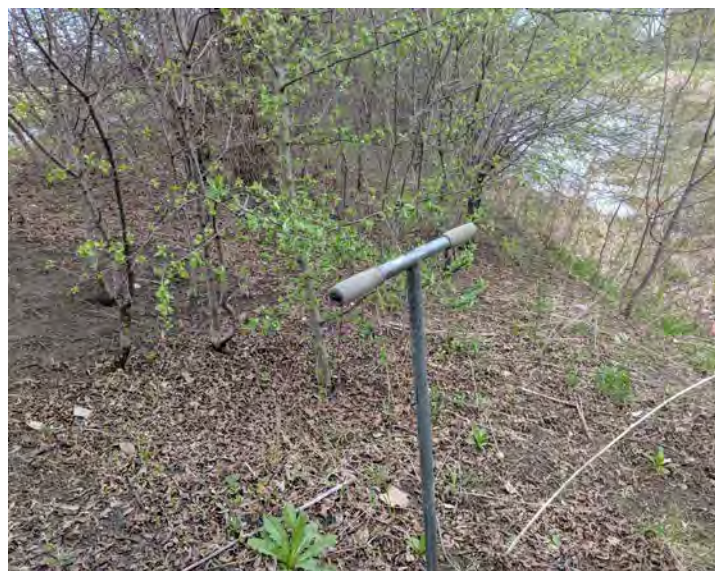
**Photo 3:** View of Wetland 1 fringe along Ginger Creek (Waters 1). View looking west.

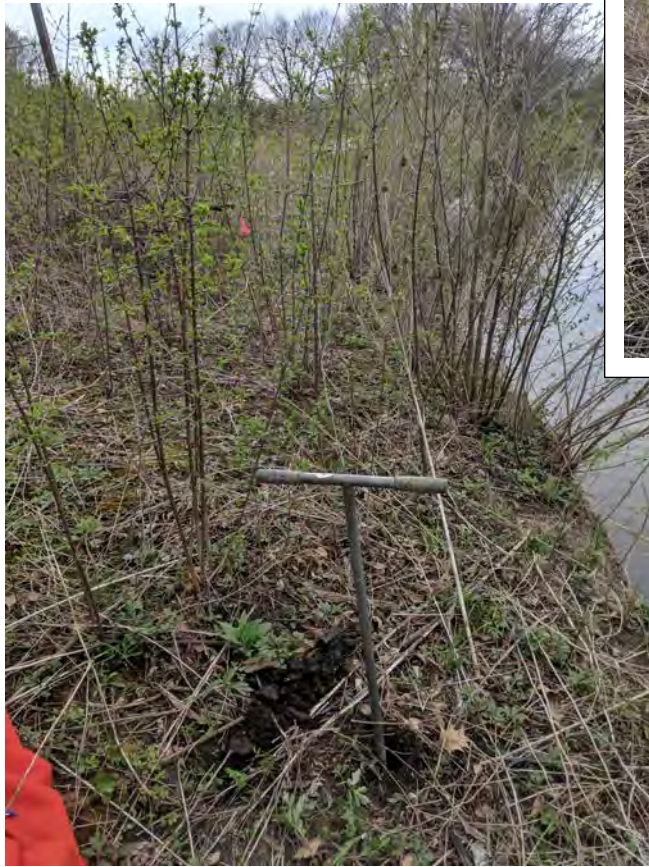
**Photo 4:** View from Data Point 2A in Wetland 2 looking west.

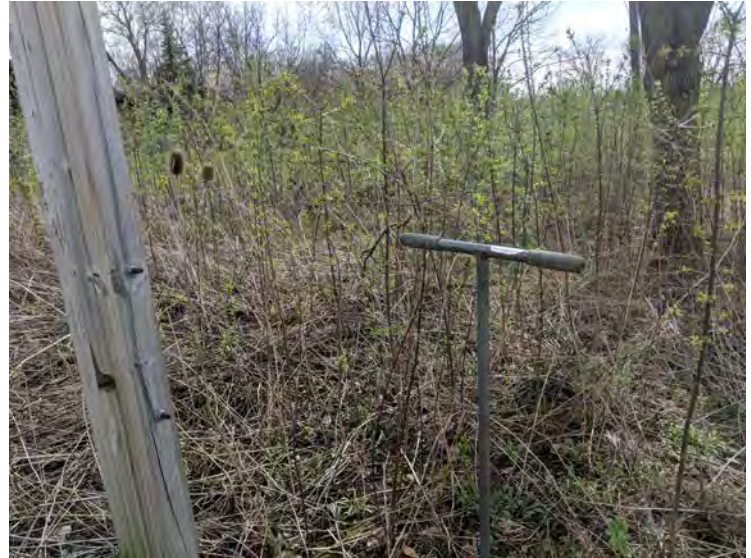
**Photo 5:** View from Data Point 2B in the upland adjacent to Wetland 2 looking west.

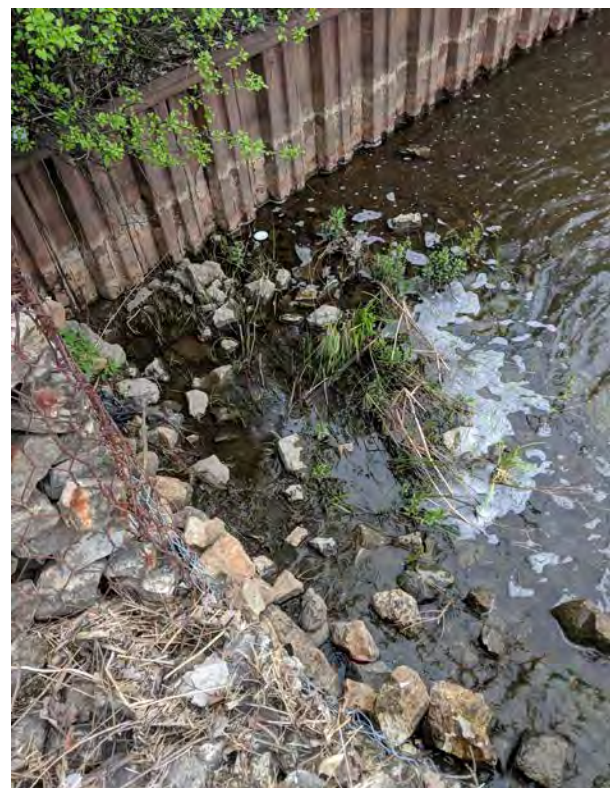
**Photo 6:** View of wetland plant community growing within Waters 1 near dam and sea wall.

A plant community consisting of Great Bulrush (*Schoenoplectus tabernaemontani*), sedges (*Carex* spp.), and Water Willow (*Justicia Americana*) was observed just east of the dam structure located in the center of Ginger Creek. The plant community was located in a small area (approximately 6'x5') where the dam structure and sea wall come together (see Photo 6). Despite the presence of hydrophytic vegetation and hydrology, this area was delineated as part of the Waters of the U.S. due to the presence of piled rock and riprap preventing a soil sample from being obtained.

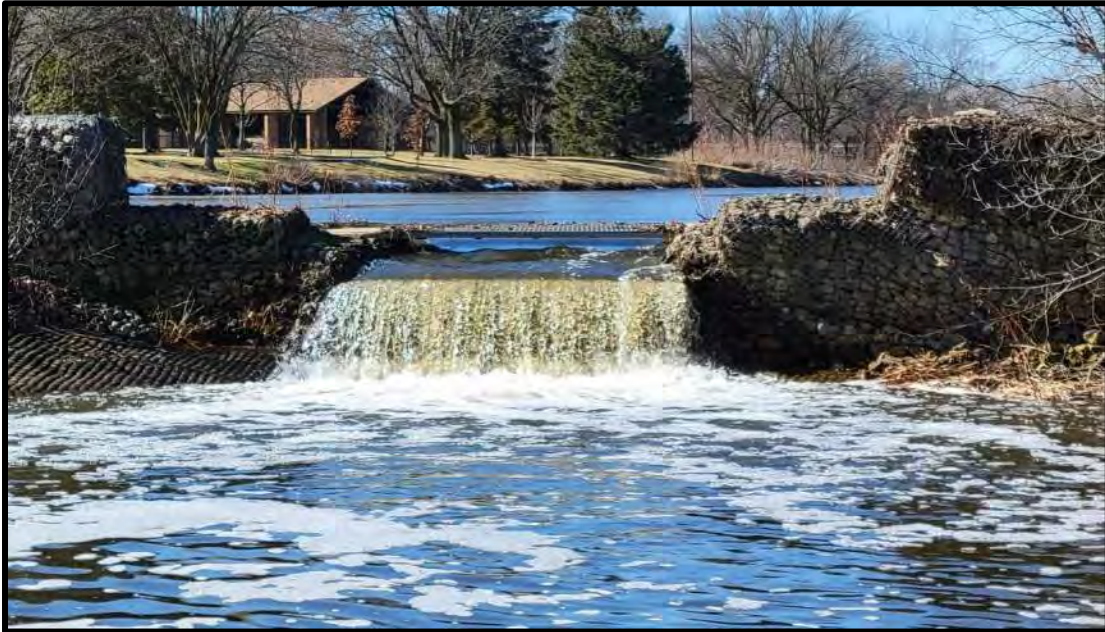
Photograph 1: Downstream face of the structure – Looking east

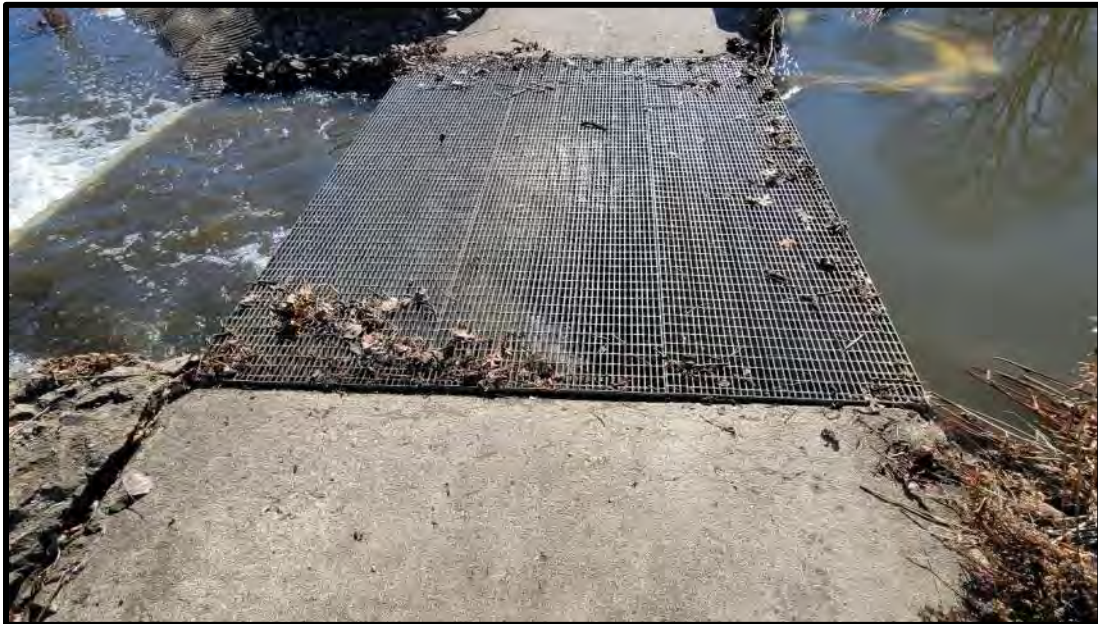
Photograph 2: Spider cracking in north approach slab & debris buildup on grate

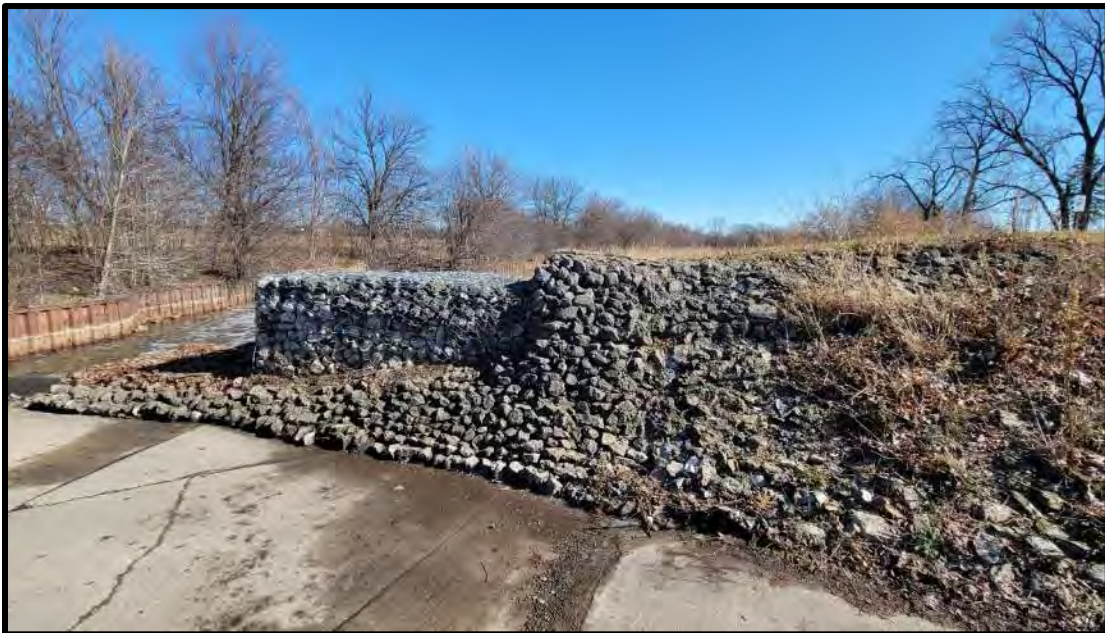
Photograph 4: South gabion wall and south approach path – Looking east

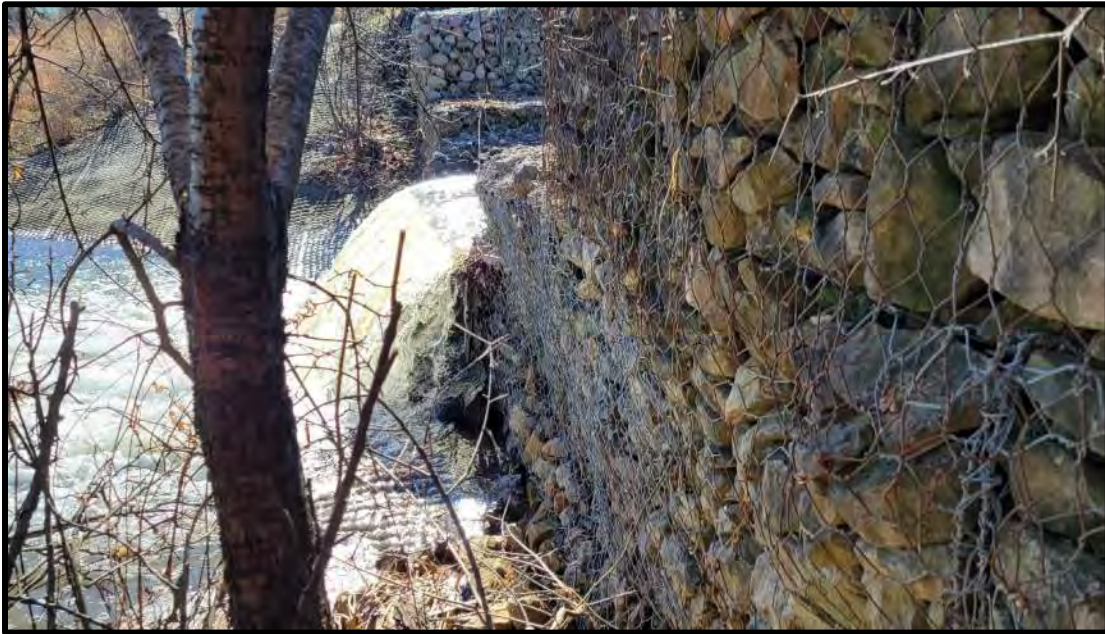
Photograph 5: East face of northern gabion wall - Looking south

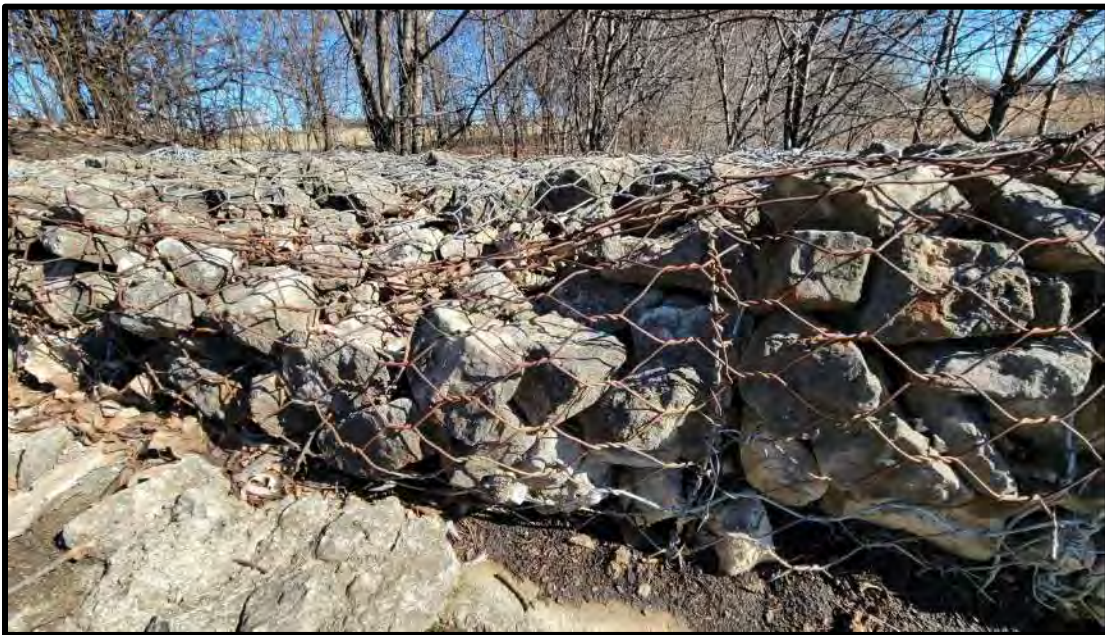
Photograph 6: Rock displacement, wire distortion and corrosion at gabion wall

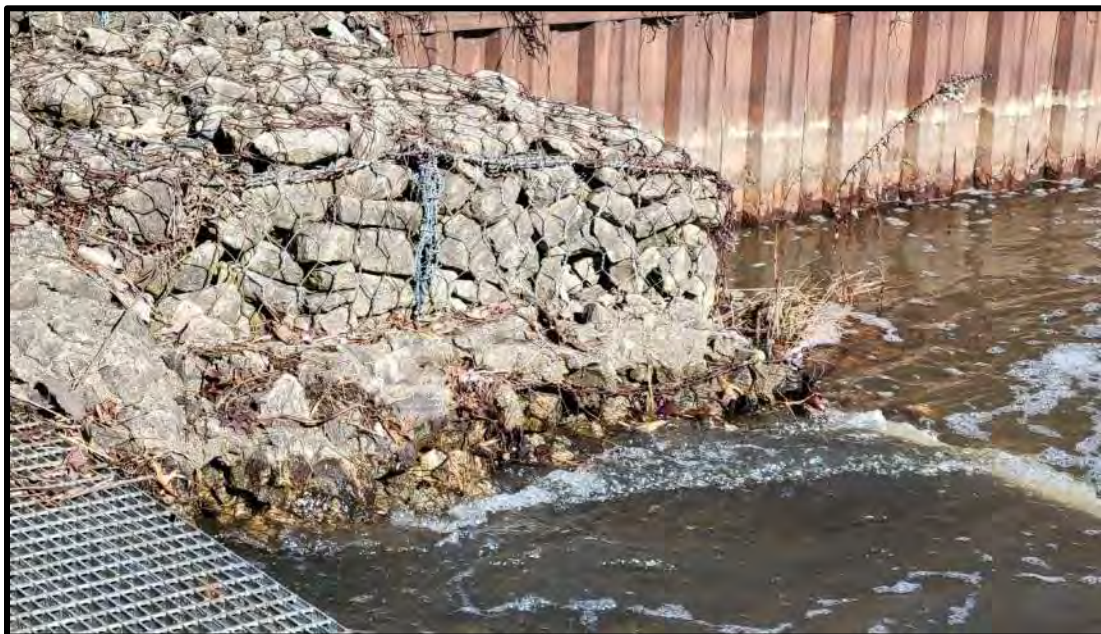
Photograph 7: Rock displacement, wire distortion and corrosion at gabion wall

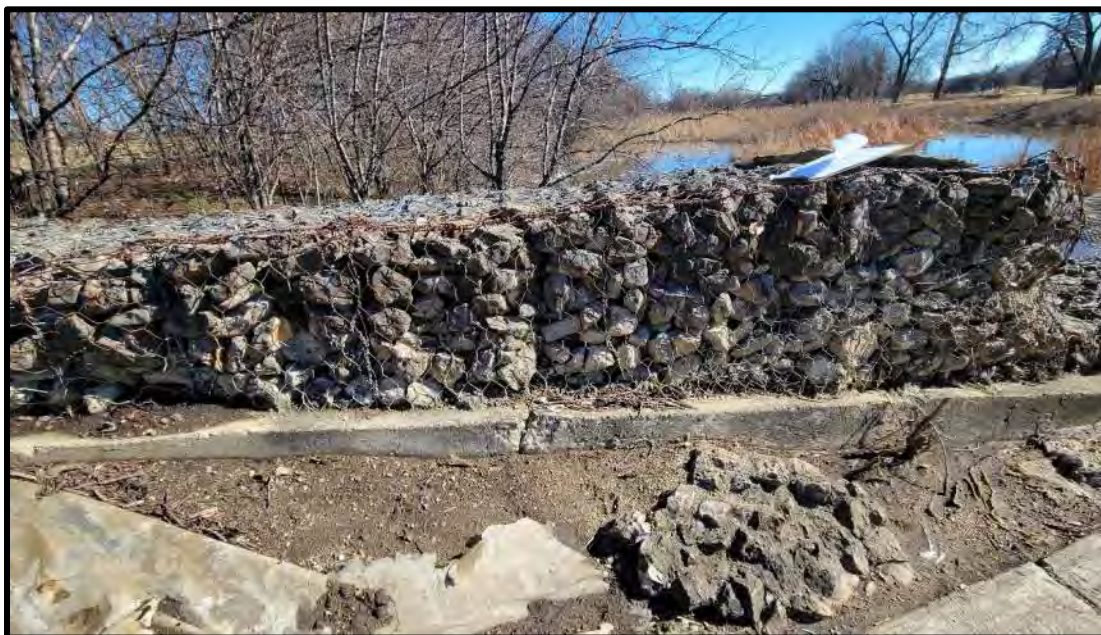
Photograph 8: West face of north concrete & gabion retaining wall – Looking east

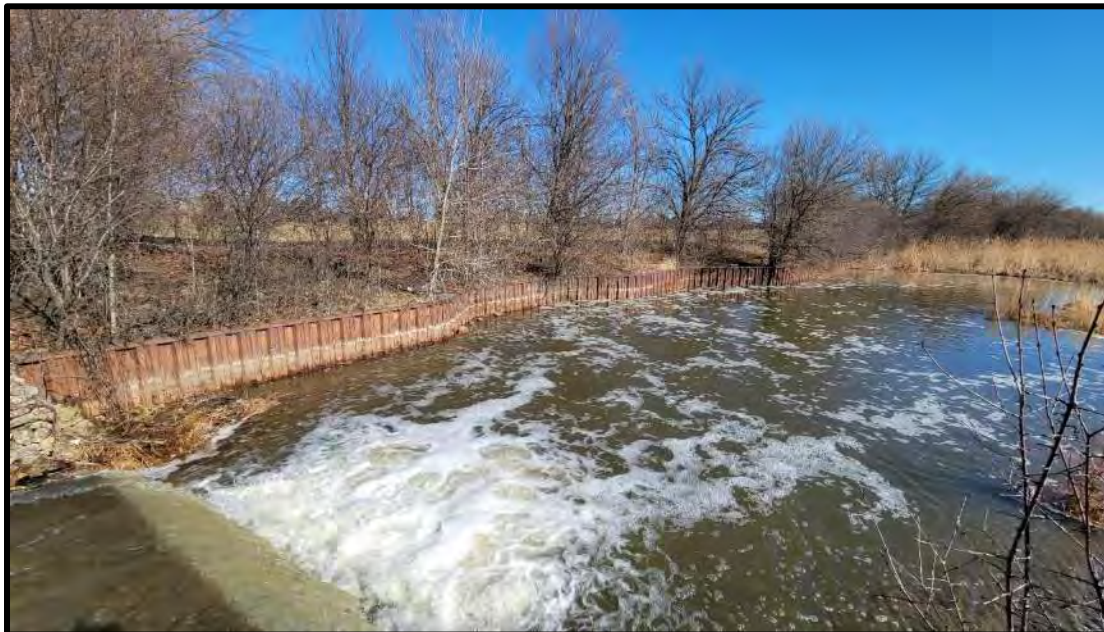
Photograph 9: Sheet pile retaining wall – Looking northeast

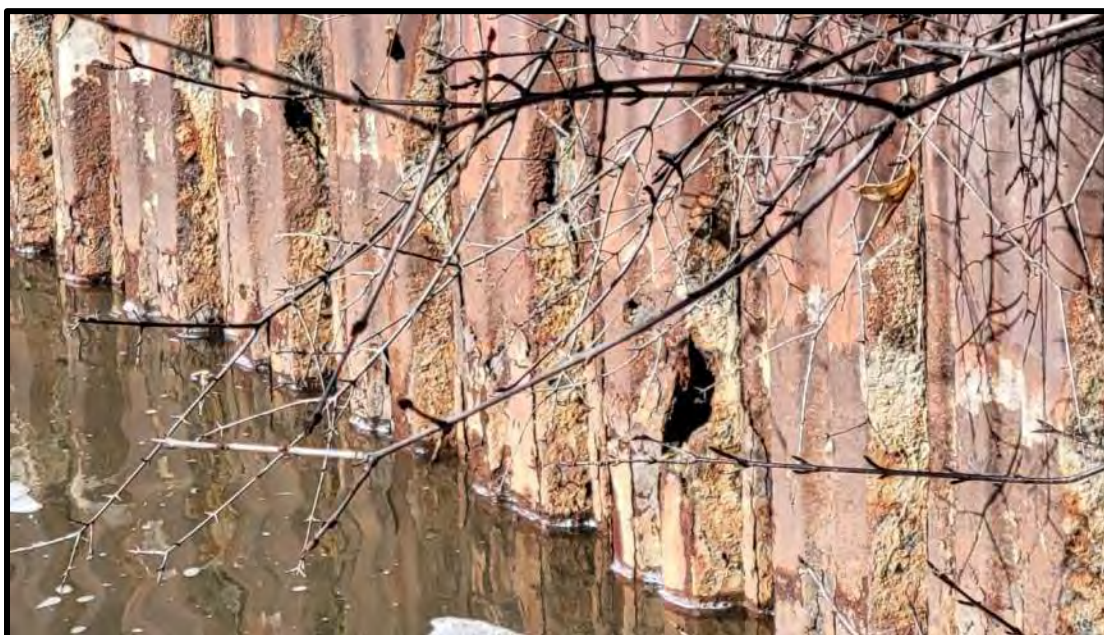
Photograph 10: Pitting & scaling of steel and visible holes on face of sheet pile wall

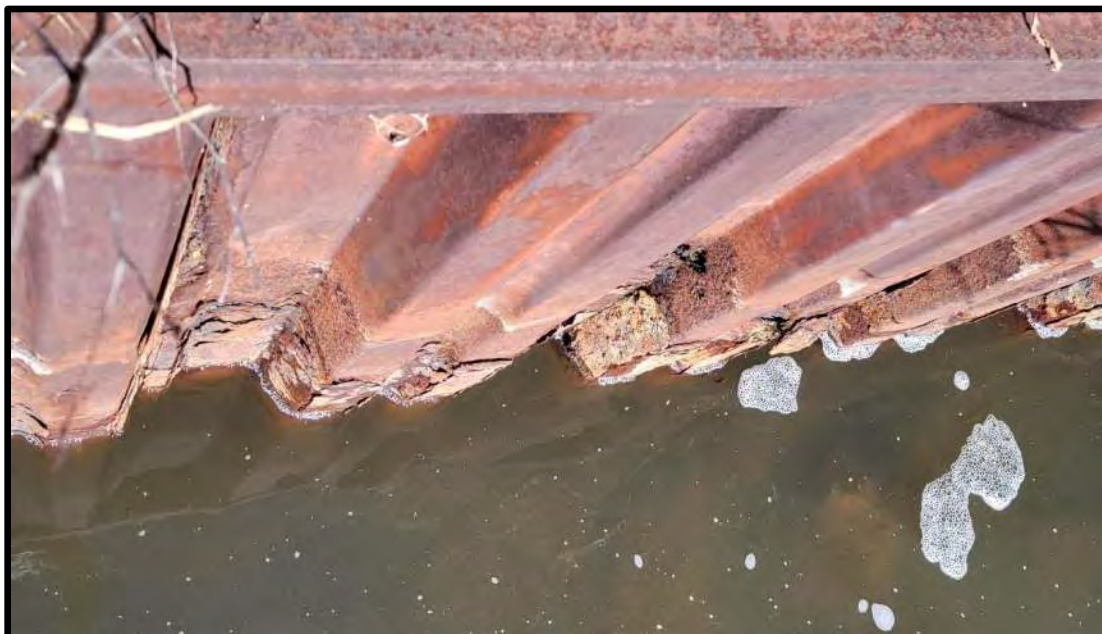
Photograph 11: Steel scaling, section loss and visible holes on face of sheet pile wall

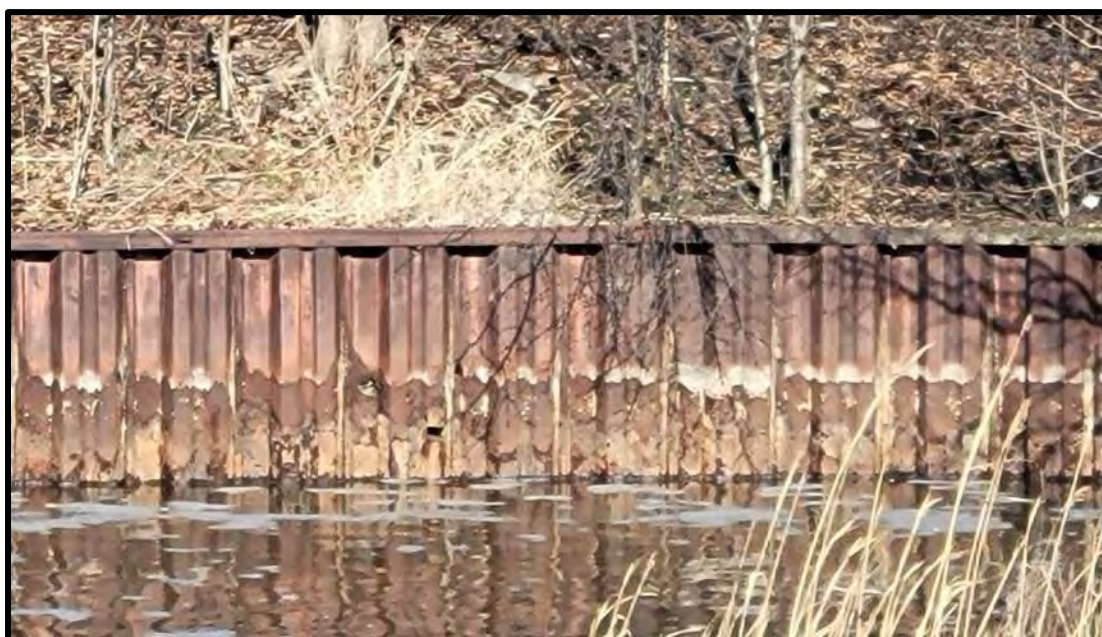
Photograph 12: Deterioration of steel sheet pile retaining wall

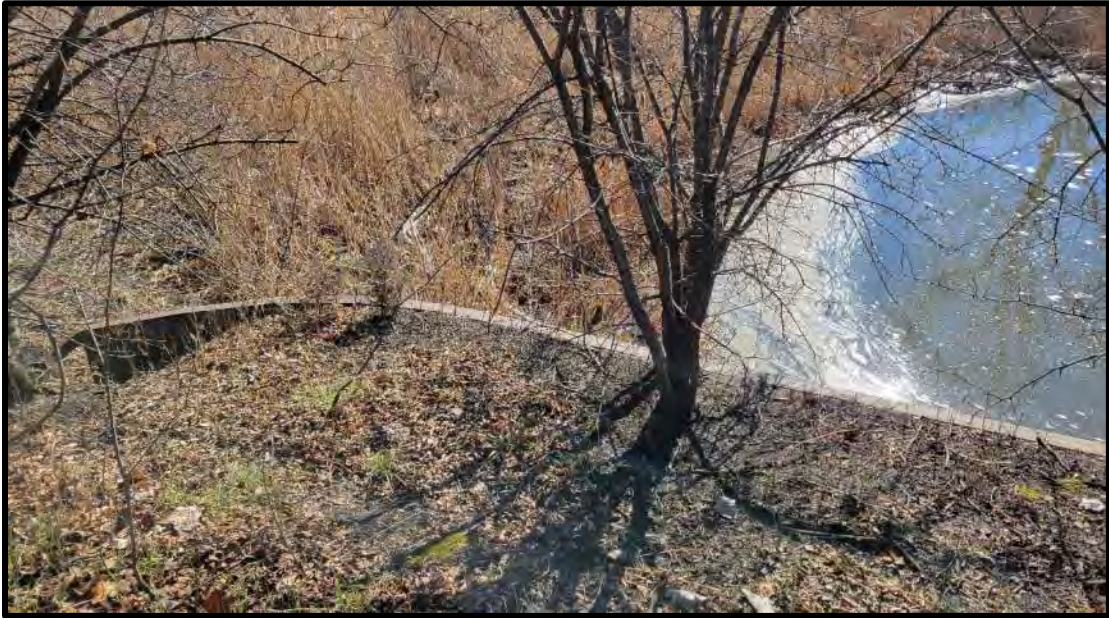
Photograph 13: East end of sheet pile retaining wall – Looking southeast

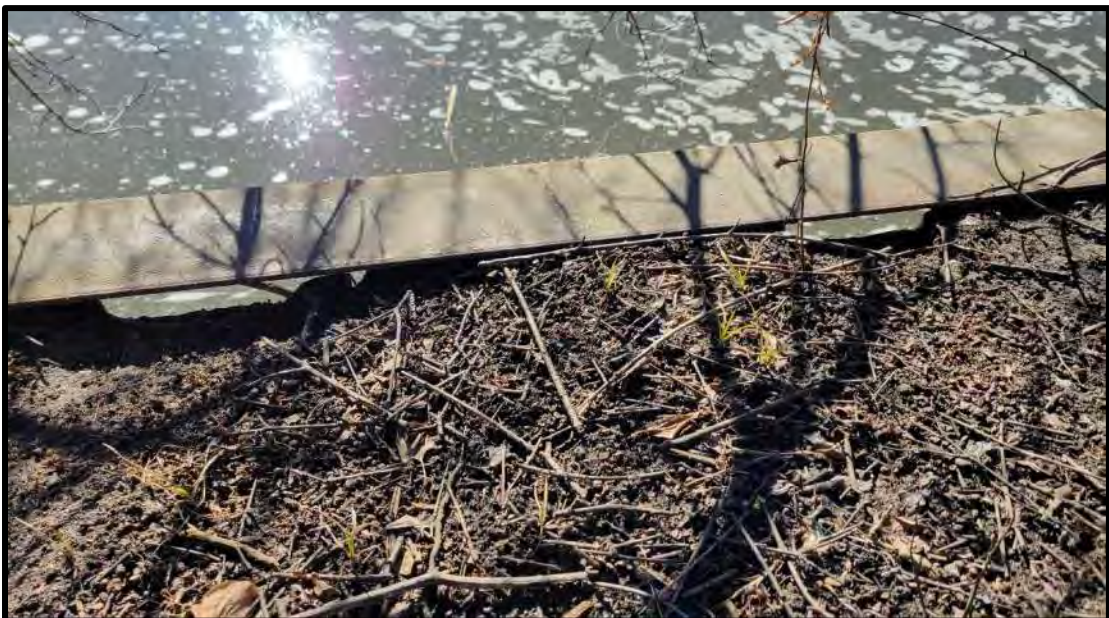
Photograph 14: Voids between the top plate and sheet piling

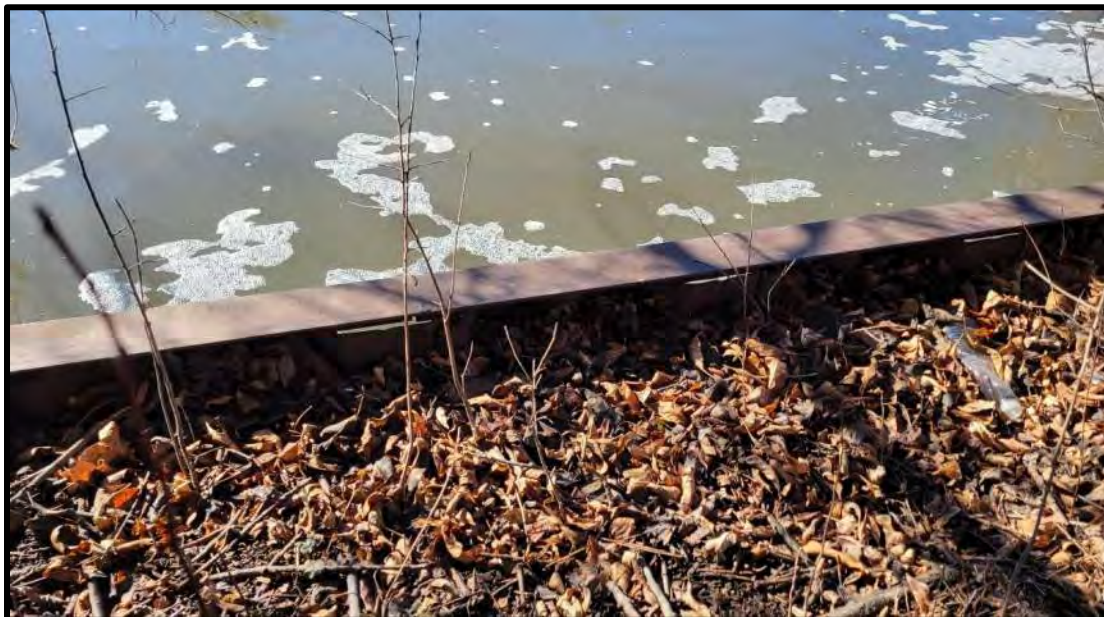
Photograph 15: Eroded backslope behind the sheet pile wall

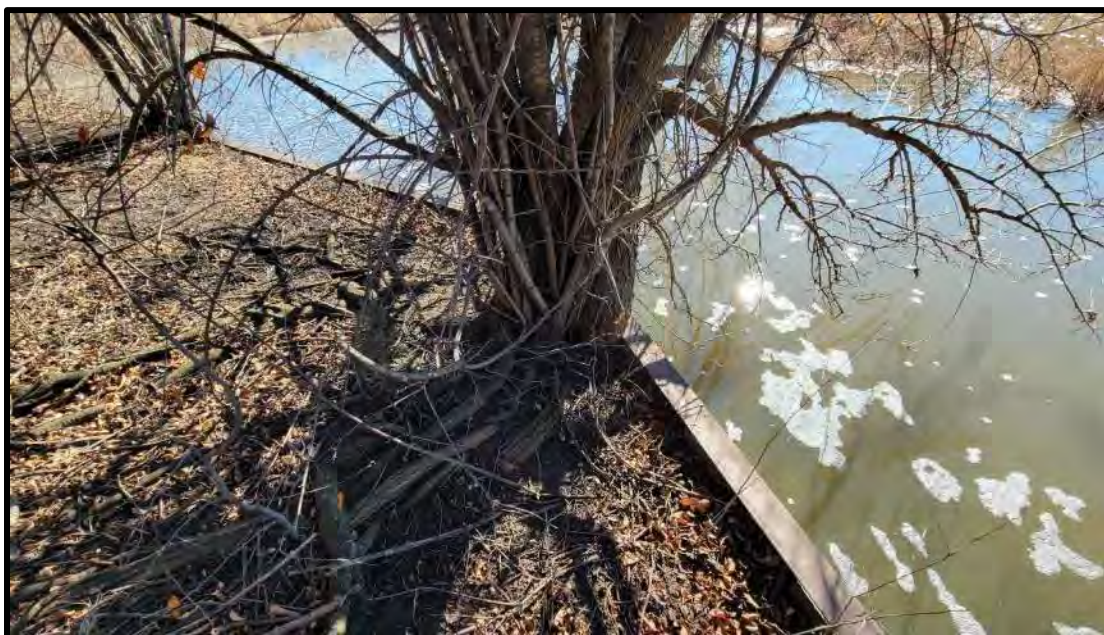
Photograph 16: Vegetative growth and slope erosion at the top of wall

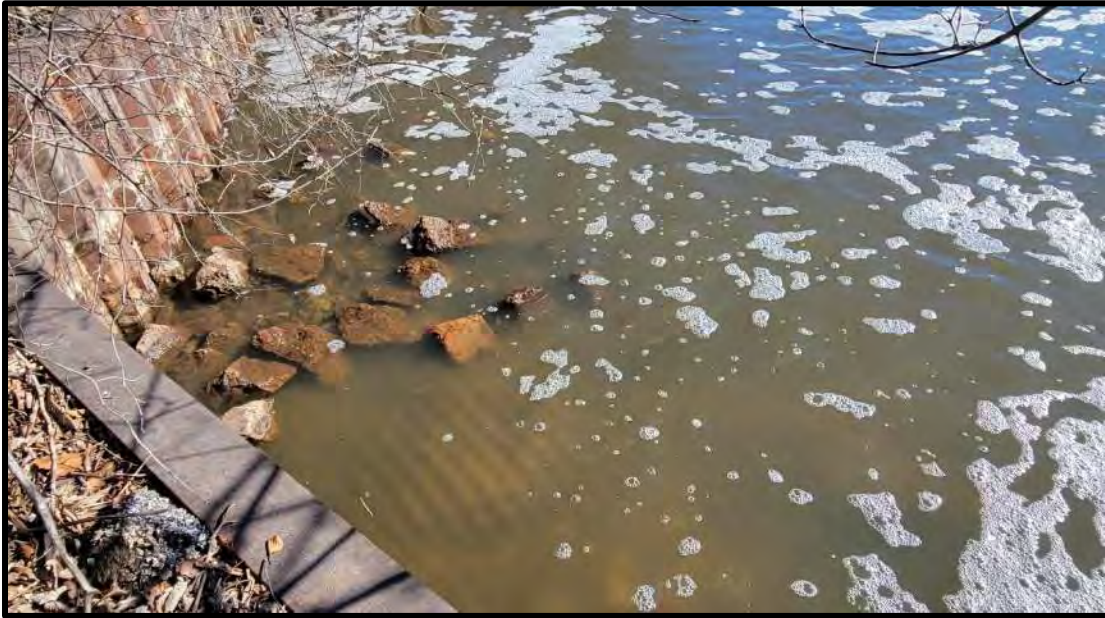
Photograph 17: Exposed top of deck at north abutment – Looking west

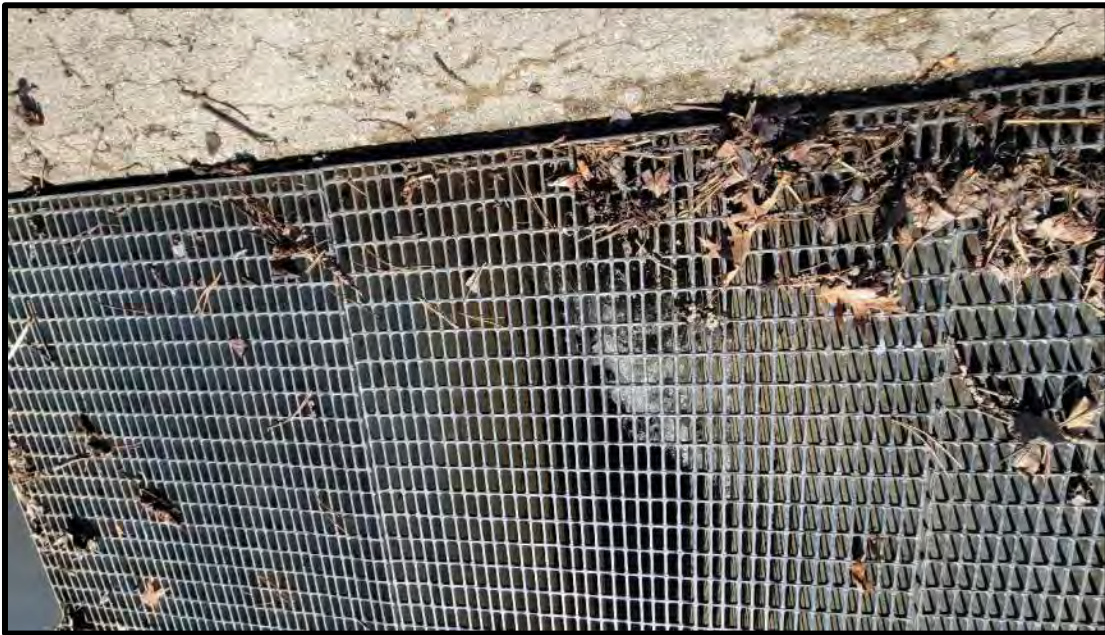
Photograph 18: Debris buildup on grate & water swirling at north footing

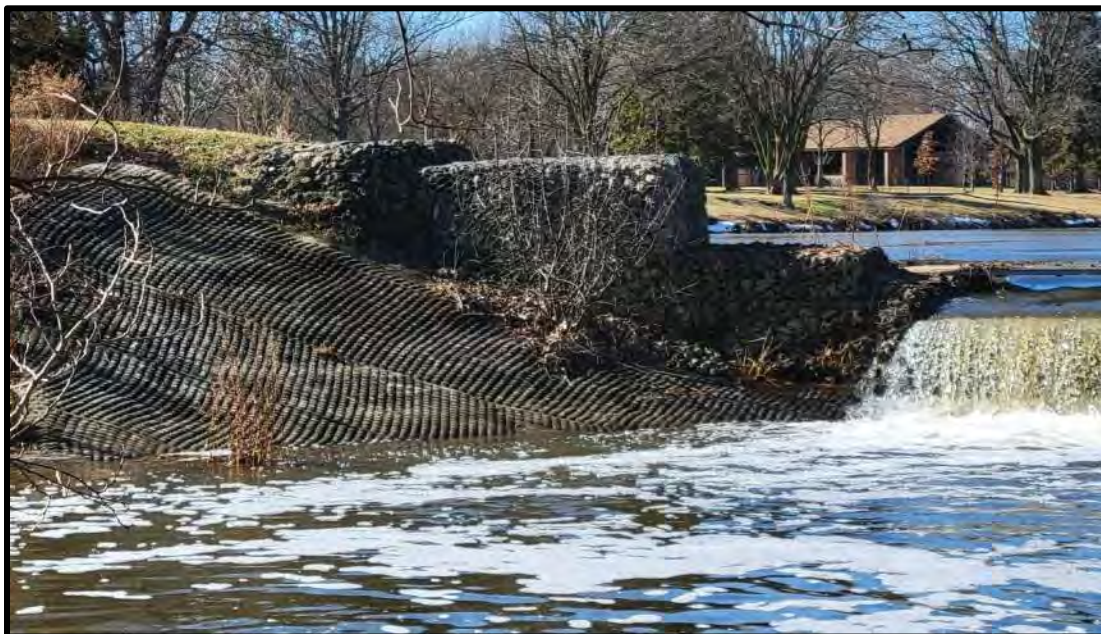
Photograph 19: CIP concrete mattress on downstream side of structure – Looking west

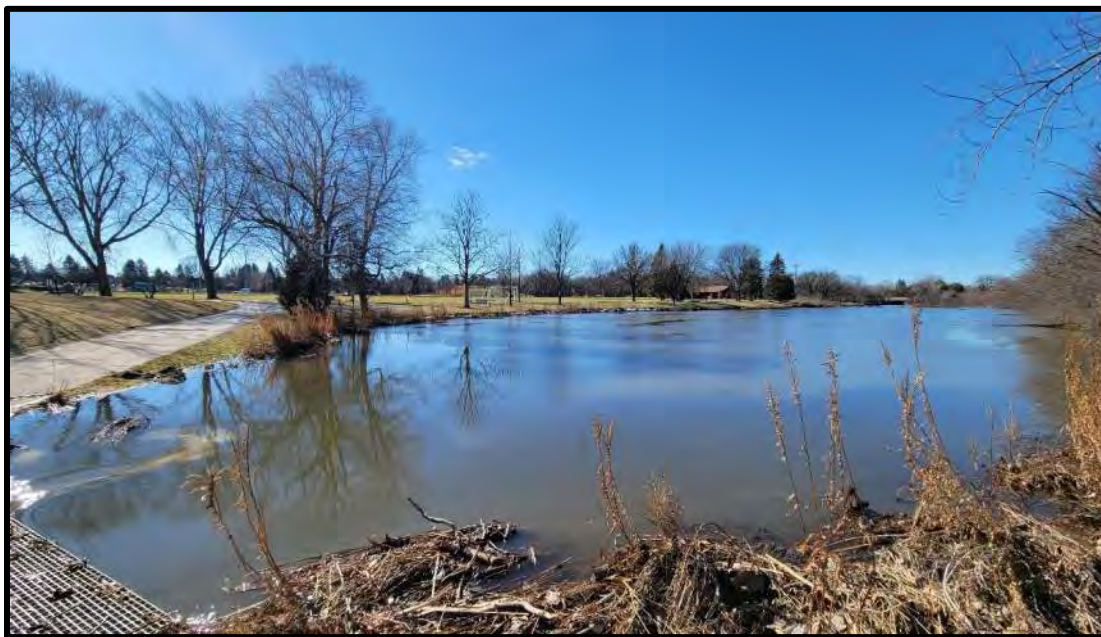
Photograph 20: Debris at upstream face of structure – Looking west

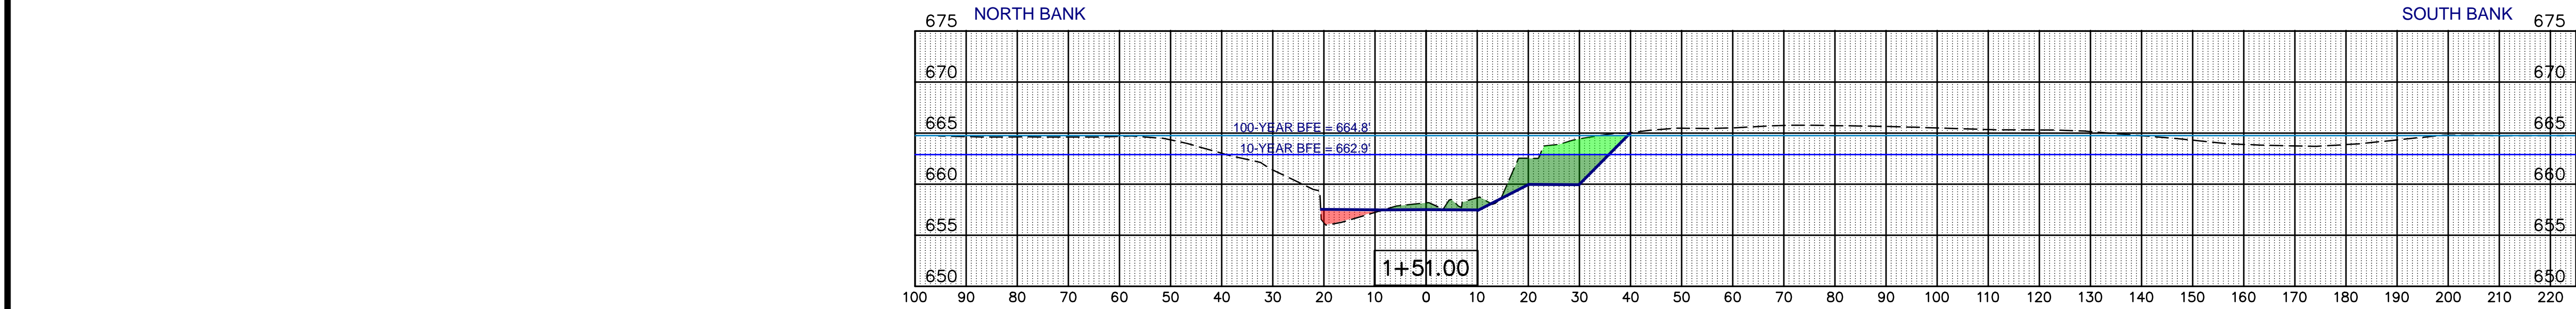
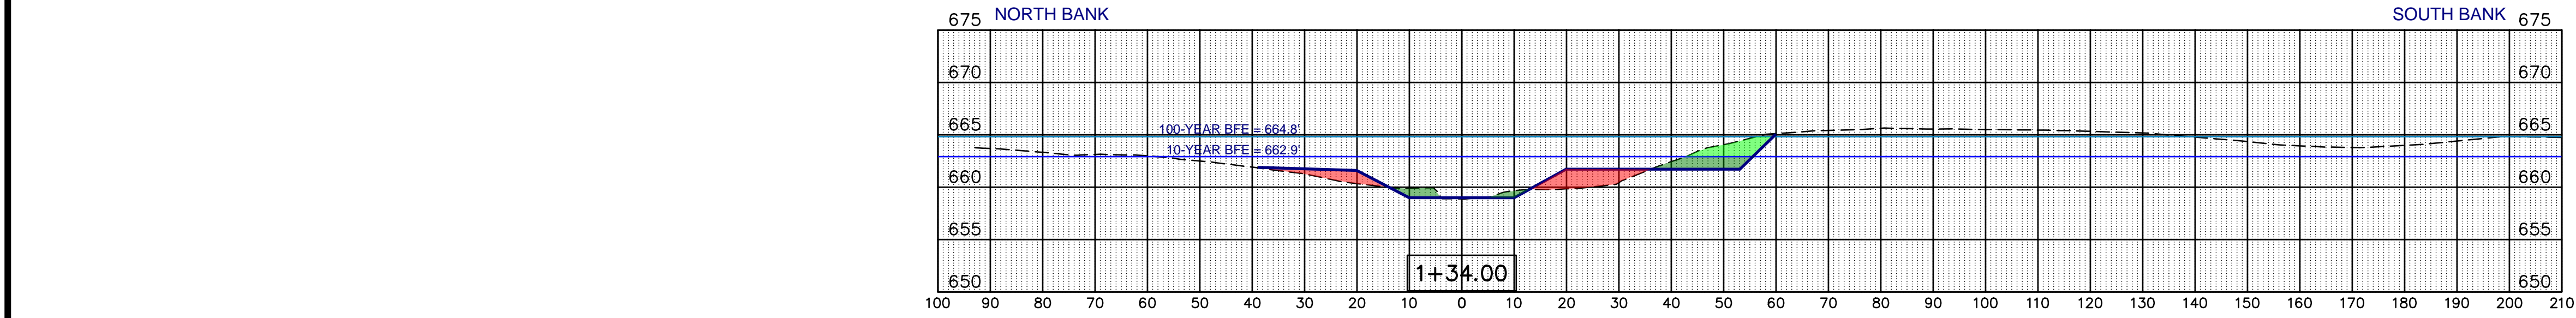
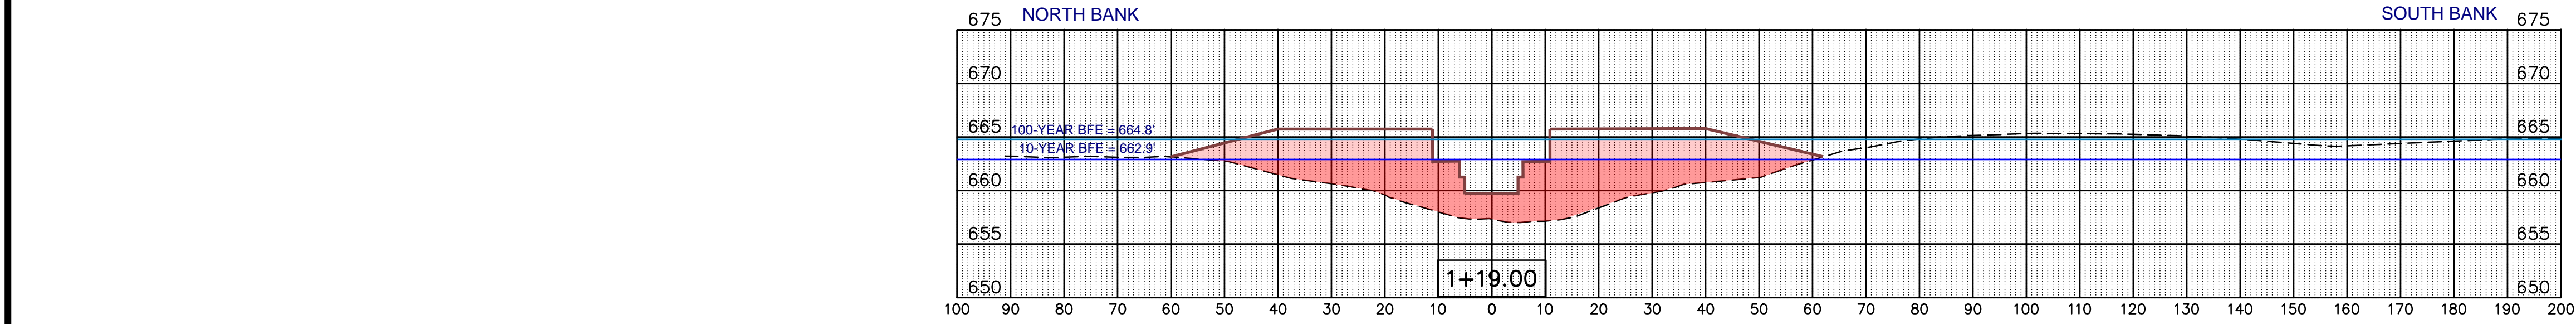
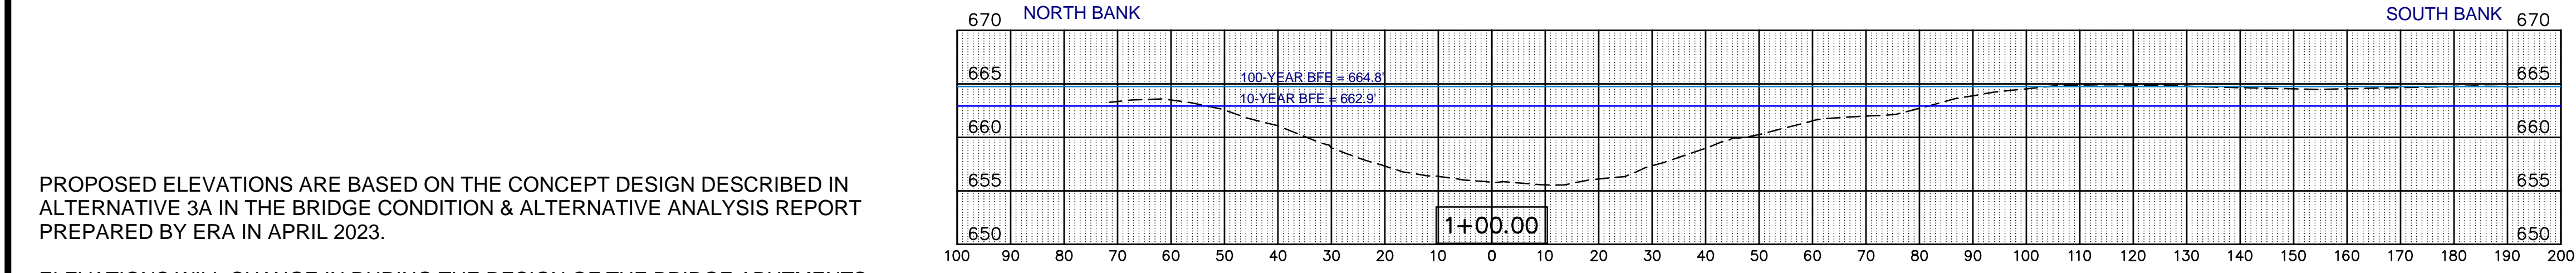
TITLE:		SCALE: 1"=20'H, 1"=10'V
CROSS-SECTIONS PROFILE A		DATE: APRIL, 2023
		JOB NO: W22314
		SHEET 1 OF 2

PROPOSED ELEVATIONS ARE BASED ON THE CONCEPT DESIGN DESCRIBED IN ALTERNATIVE 3A IN THE BRIDGE CONDITION & ALTERNATIVE ANALYSIS REPORT PREPARED BY ERA IN APRIL 2023.

ELEVATIONS WILL CHANGE IN DURING THE DESIGN OF THE BRIDGE ABUTMENTS, DAM LOCATION AND STREAM GRADING REQUIRED FOR LOW FLOWS AND FISH PASSAGE.
