**Oak Brook Park District  
1450 Forest Gate Road  
Oak Brook, IL 60523**

**REQUEST FOR LETTERS OF INTEREST AND STATEMENTS OF QUALIFICATIONS FOR  
PROFESSIONAL SERVICES**

# Bridge Condition & Alternative Analysis Report

# GINGER CREEK CONTROL FACILITIES

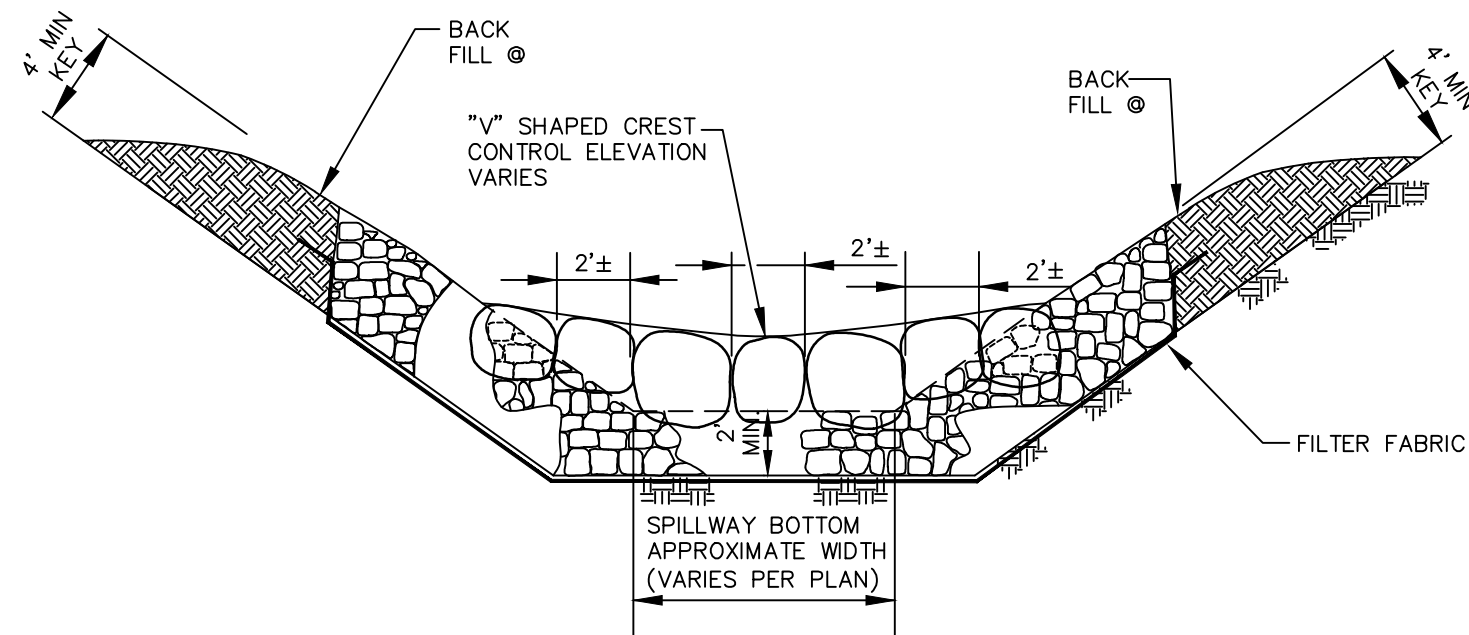
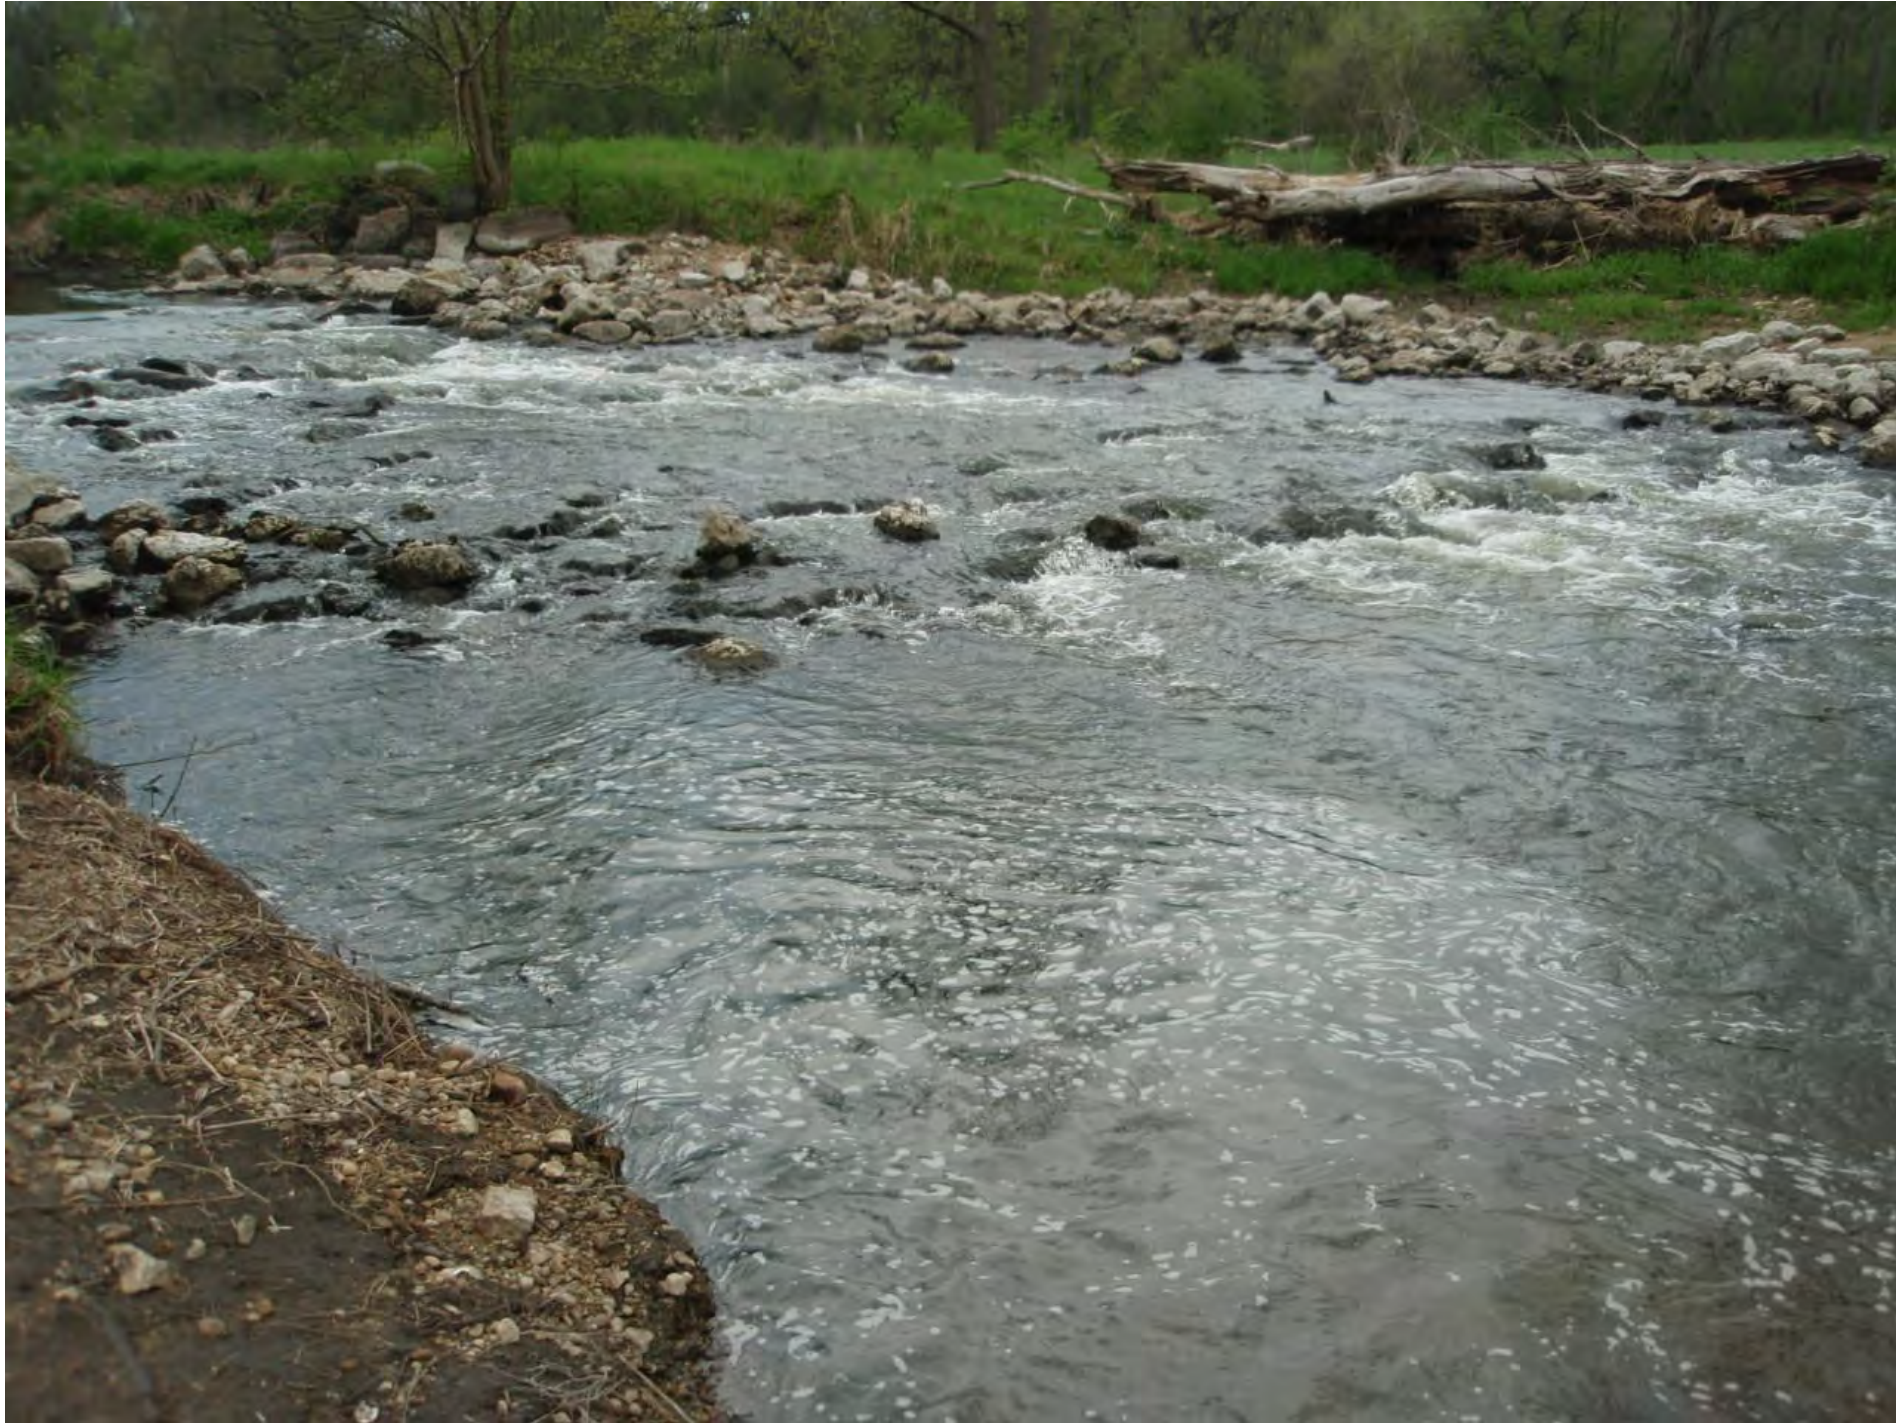
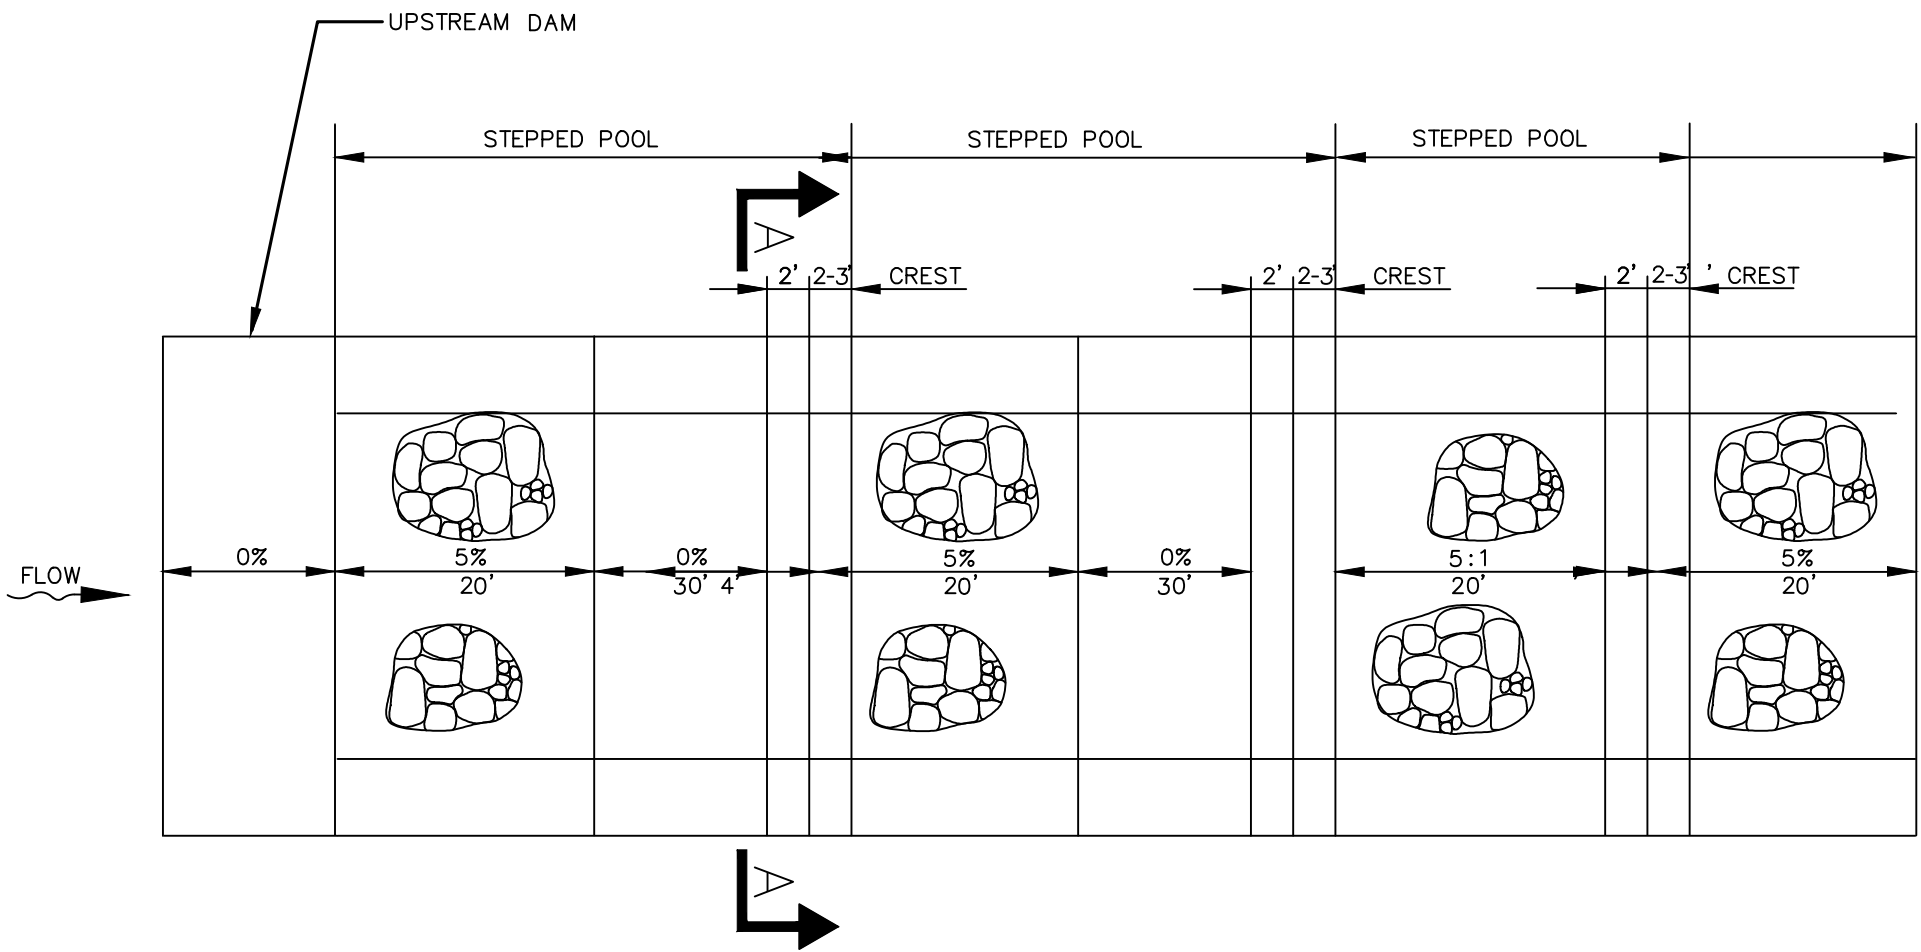
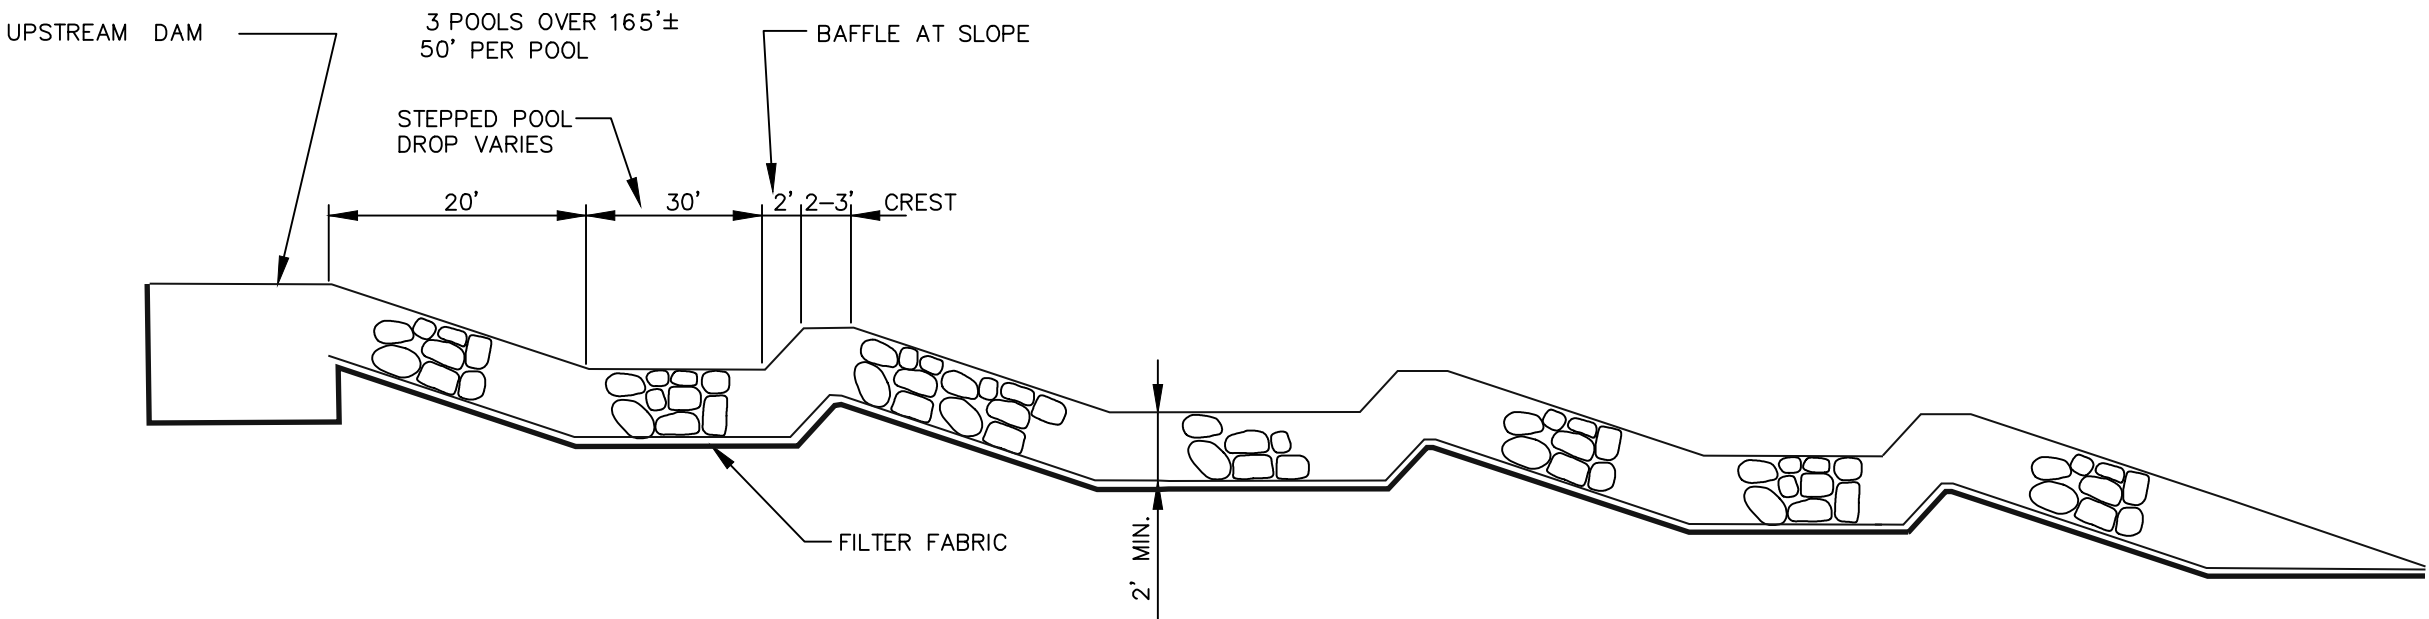
STEPPED POOL DETAIL

SECTION A-A

PLAN

PROFILE
